INSIGHT PROPERTY INSPECTIONS, LLC

## RESIDENTIAL REPORT

1234 Main Street  
Wilmington, NC 28409

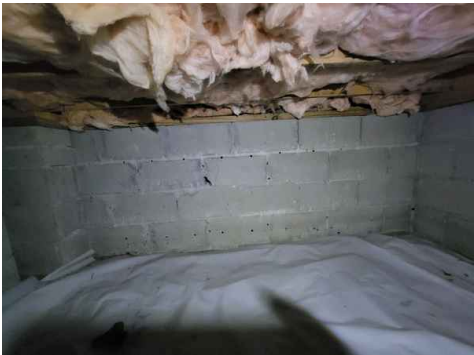
**RESTRICTED VIEW OF PORCH**

The underside of the front Porch is not able to be view. Any issues within the structure cannot be reported.

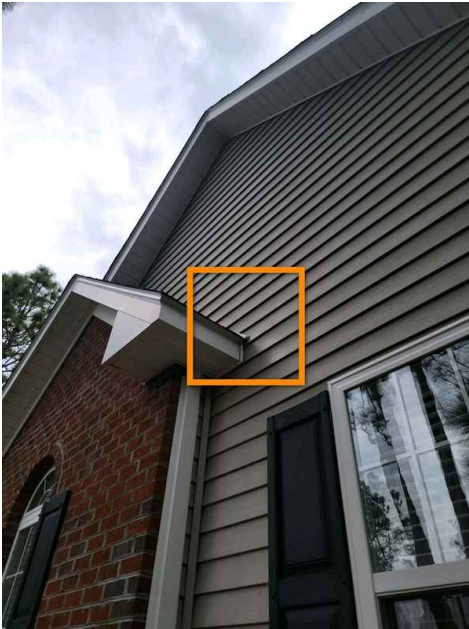
2.2.1 Siding, Flashing & Trim

**MISSING KICKOUT FLASHING**

The kickout flashing was not installed. This allows water runoff from the roof to travel down the siding, potentially increasing the amount of water that can penetrate the siding. Recommend qualified siding contractor to correct.

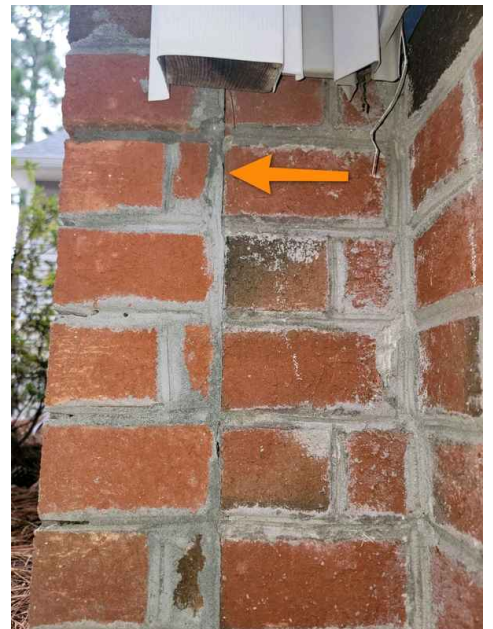
#### 2.2.2 Siding, Flashing & Trim

##### **BRICK VENEER MORTAR CRACKING**

The mortar of the brick veneer is cracked where two sections of the veneer meet. This can allow water intrusion or be a sign that the veneer is separating from the structure. Recommend qualified masonry contractor for evaluation and correction if needed.

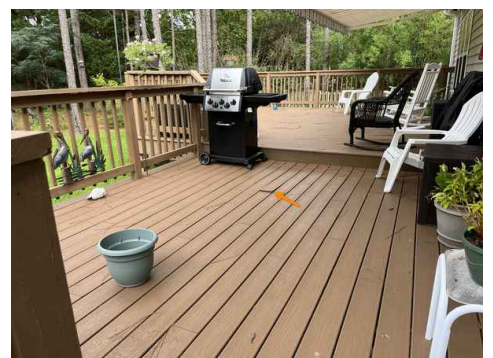
#### 2.4.1 Decks & Steps

##### **DECK - LOOSE BOARDS**

One or more deck boards were observed to be loose and are a tripping hazard. Recommend they be refastened.

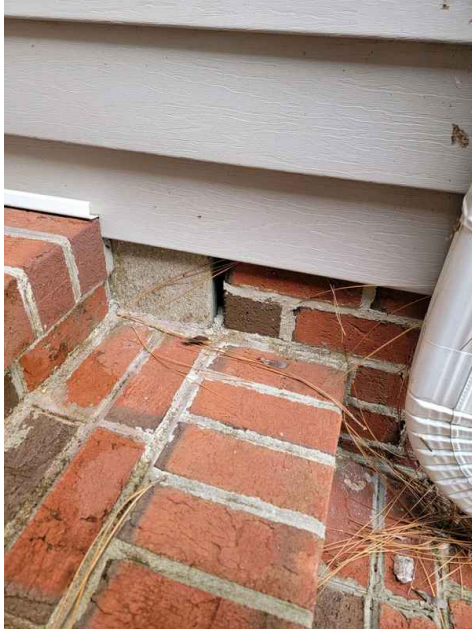
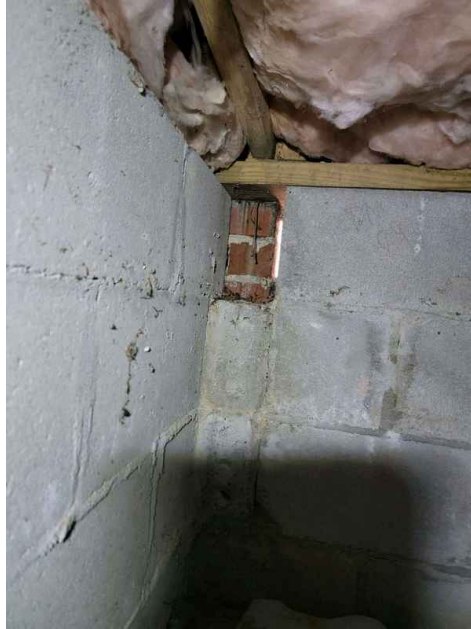
## 2.5.1 Porches &amp; Steps

**FRONT PORCH BRICK MORTAR MISSING**

The brick mortar in the steps at the covered porch is deteriorated and missing. This can allow wildlife and water to enter the crawlspace, potentially causing damage to the structure. Recommend general contractor/masonry contractor to repair.

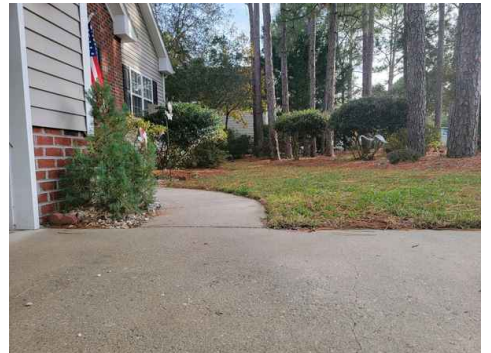
## 2.7.1 Vegetation, Grading, Drainage &amp; Retaining Walls

**INSUFFICIENT GRADING**

In multiple areas around the house, there is insufficient sloping of the landscape to promote water drainage away from the foundation. This may cause water intrusion in the crawlspace. Recommend qualified landscaping contractor for correction.

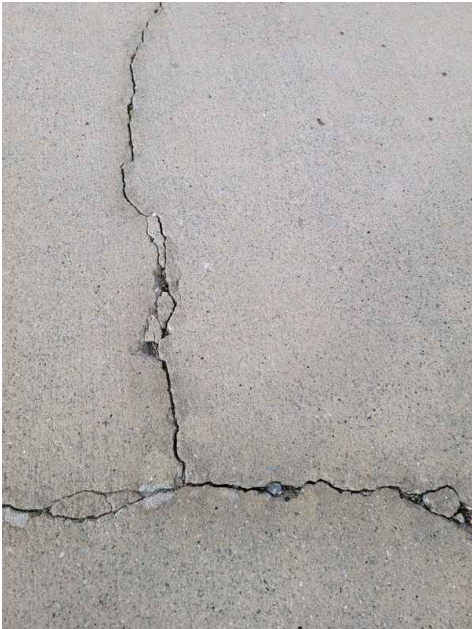
## 2.8.1 Walkways, Patios &amp; Driveways

**DRIVEWAY CRACKING - MINOR**

Minor cosmetic cracks observed, which may indicate movement in the soil. Recommend monitor and/or have driveway contractor patch/seal.

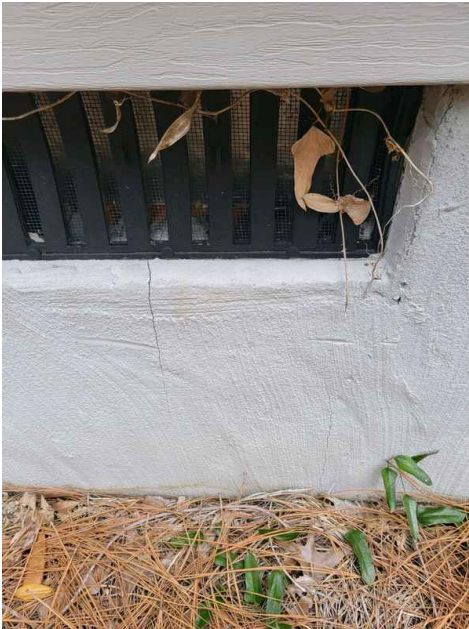
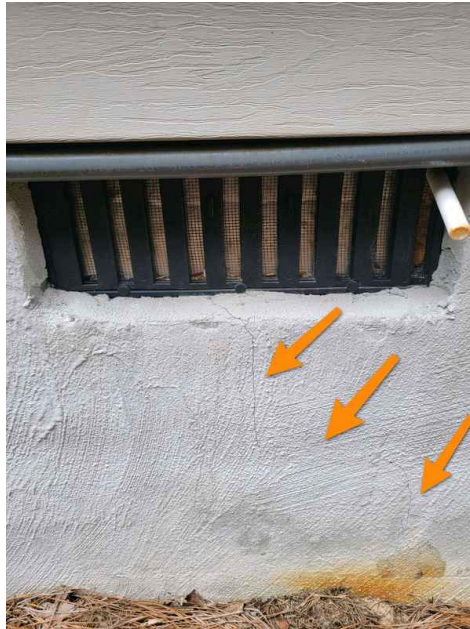
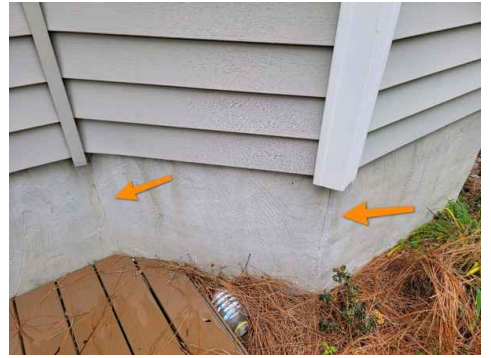
4.1.1 Foundation

**FOUNDATION CRACKS - MINOR**

Minor cracking was noted at the foundation. This is common as concrete ages and shrinkage surface cracks are normal. Recommend monitoring for more serious shifting/displacement.

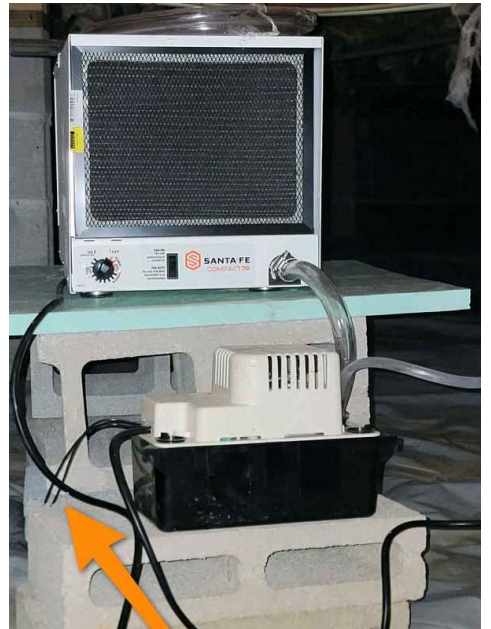
#### 4.2.1 Basements & Crawlspaces

##### **DEHUMIDIFIER NO OVERFLOW PROTECTION**

The dehumidifier drainage pump does not have any installed overflow protection or alarm. This may cause water to accumulate if the pump fails. Recommend qualified plumber to correct.

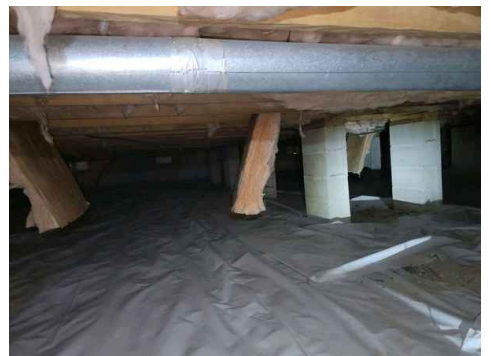
#### 4.2.2 Basements & Crawlspaces

##### **INSULATION FALLING**

The subfloor insulation is falling in multiple areas in the crawlspace. This will reduce the efficiency of heating/cooling of the first floor area and may promote moisture and microbial growth in on the crawlspace surface. Recommend qualified insulation contractor to correct.

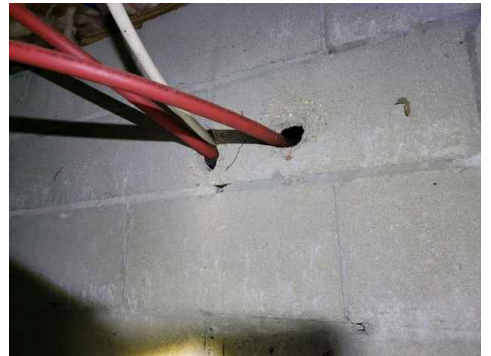
## 4.2.4 Basements &amp; Crawlspace

**HOLES NOT FULLY SEALED**

The holes in which water lines pass through the CMU are not fully sealed. This may allow water or pest intrusion. Recommend qualified contractor to correct.

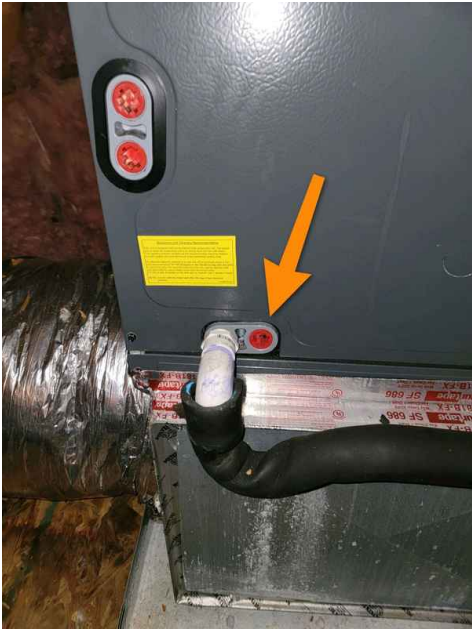
The gas forced air system does not have overflow protection. This can cause water damage if the unit were to overflow or leak. Recommend mechanical engineer for repair.

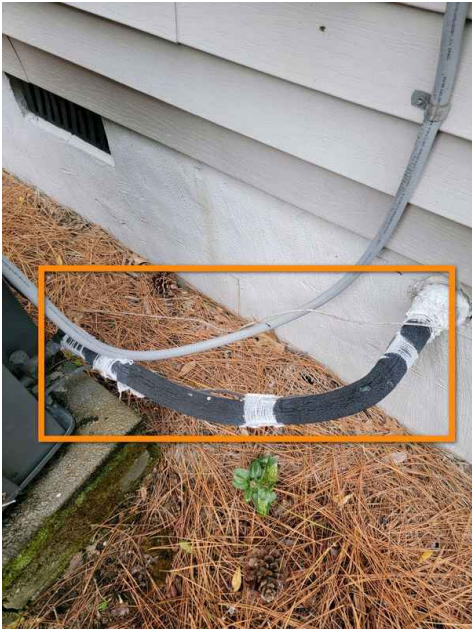
6.1.1 Cooling Equipment

INSULATION MISSING OR DAMAGED

Missing or damaged insulation on refrigerant line can cause energy loss and condensation. Recommend qualified mechanical contractor to repair/replace as necessary.

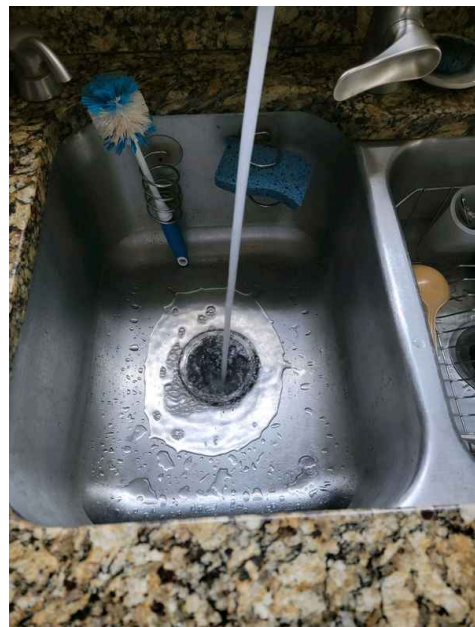
## 7.2.1 Drain, Waste, &amp; Vent Systems

**SINK - POOR DRAINAGE**

The kitchen sink had slow/poor drainage. This may cause the sink to overflow if left unattended. Recommend a qualified plumber repair.

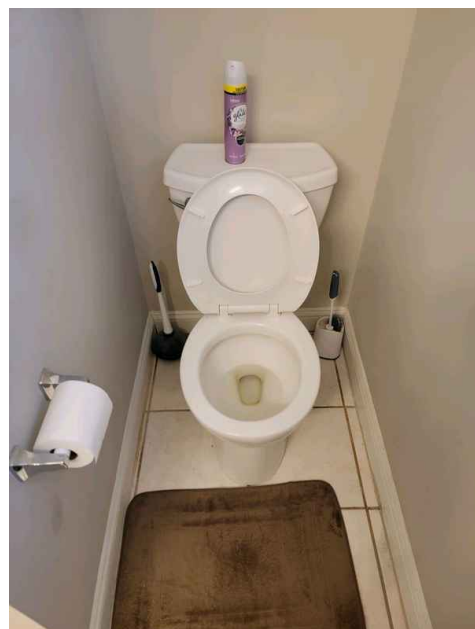
## 7.2.2 Drain, Waste, &amp; Vent Systems

**TOILET LOOSE**

The toilet is not securely attached to the subflooring. This will allow leakage and water intrusion into the surrounding structure. Recommend qualified plumbing contractor to correct.

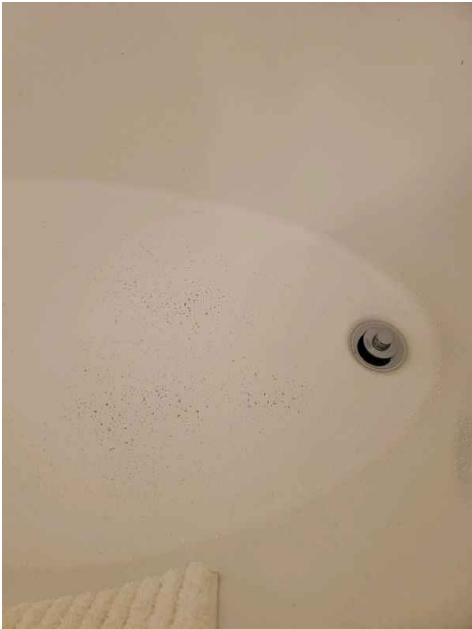
## 7.2.3 Drain, Waste, &amp; Vent Systems

**SEDIMENT NOTED**

When operating the bathtub, a large amount of sediment was released. This may be an indication of buildup in the supply pipes or water heater and may be damaging the equipment. Recommend qualified plumbing contractor for evaluation and correction.

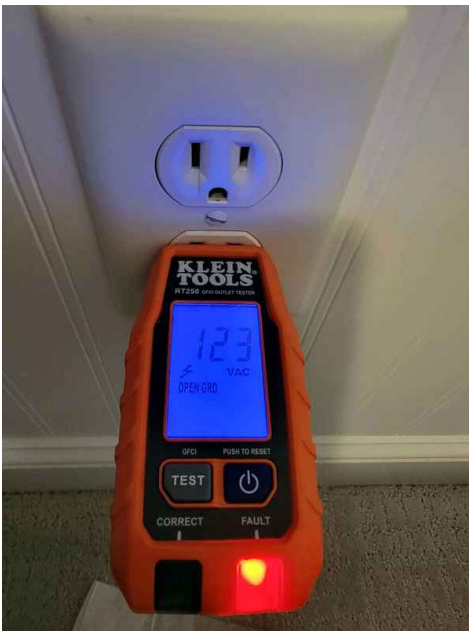
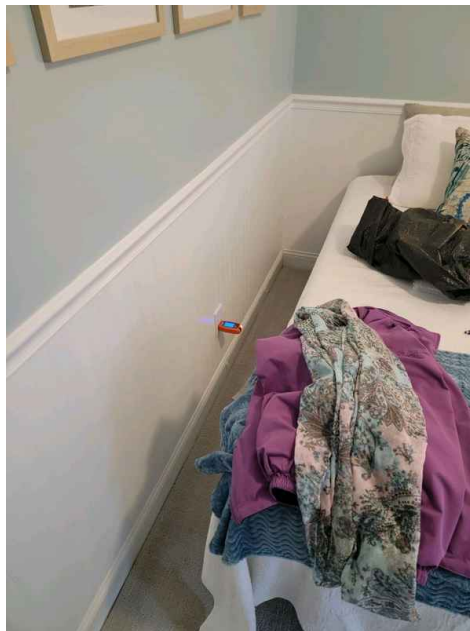
### 8.3.1 Branch Wiring Circuits, Breakers & Fuses

#### **IMPROPER WIRING**

All electrical receptacles tested in the right bedroom show an open ground fault. This is both a shocking hazard and a fire hazard as the outlets are not grounded. Recommend qualified electrical contractor to correct.

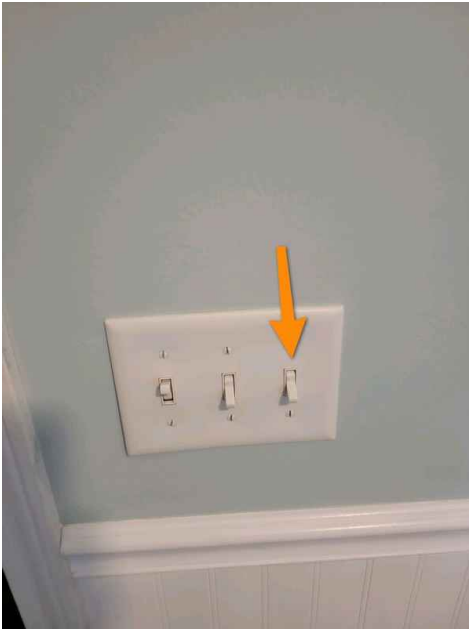
### 8.4.1 Lighting Fixtures, Switches & Receptacles

#### **SWITCHES INSTALLED IMPROPERLY**

One or more switches are installed or wired improperly and are inoperable. This may be a fire hazard. Recommend licensed electrician to asses/correct as needed.

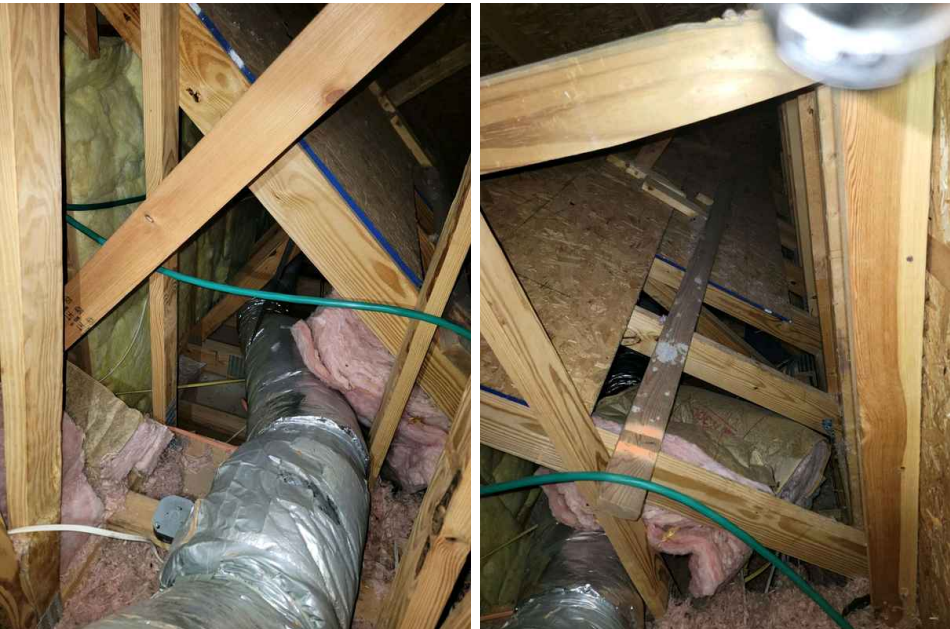
MISSING INSULATION

FRONT LEFT VIEW FROM ATTIC ACCESS

Insulation is missing in the front right attic. This reduces the efficiency of heating/cooling equipment and may promote condensation. Recommend a qualified insulation contractor to assess and correct.

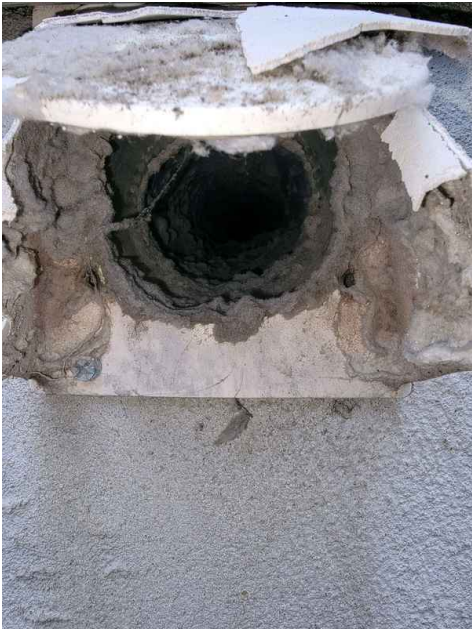
9.4.1 Exhaust Systems

DRYER DUCT FILLED WITH LINT

The dryer duct was found to have a large quantity of built up lint. This is a fire hazard. Recommend cleaning by a qualified contractor.

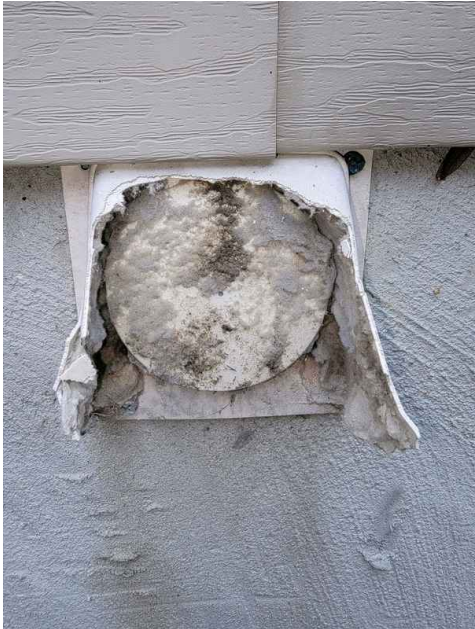
9.4.2 Exhaust Systems

**DRYER VENT BROKEN**

The dryer vent cap is broken. This may allow water intrusion around the ductwork. Recommend qualified contractor to replace.

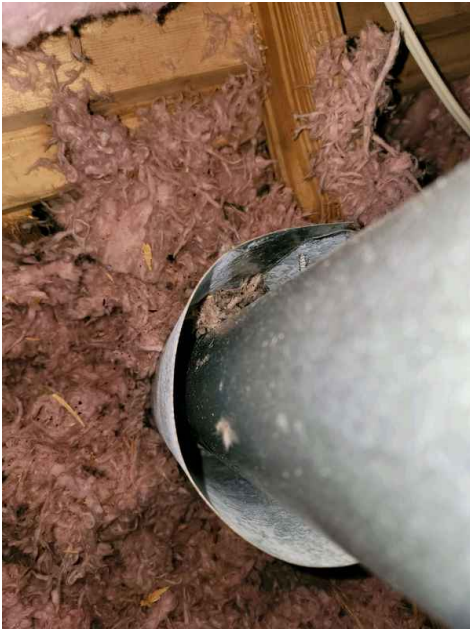
9.4.3 Exhaust Systems

**FLAMMABLE MATERIAL IN CONTACT WITH EXHAUST VENT**

A small amount of insulation and other material has fallen between the shroud and exhaust piping of the fireplace. This can be a fire hazard. Recommend qualified mechanical contractor to correct.

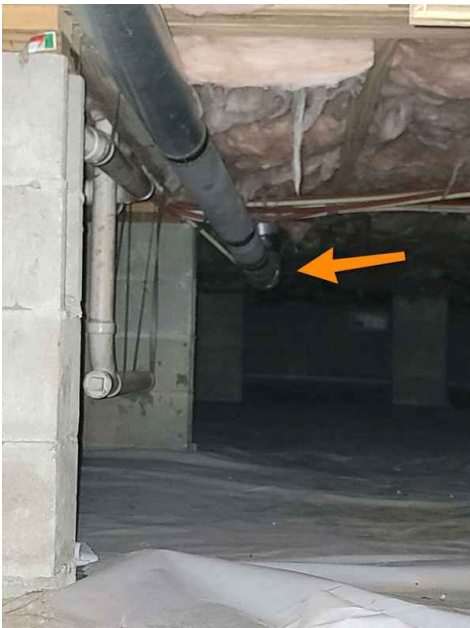
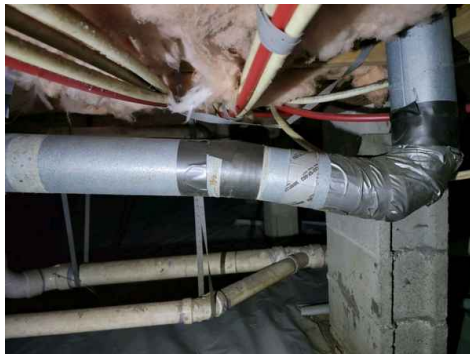
#### 9.4.4 Exhaust Systems

##### **DRYER DUCT INSUFFICIENT SLOPE**

The dryer duct elevates after entering the crawlspace. The duct should be a continual slope toward the exterior to reduce lint buildup, which can be a fire hazard and reduce the dryer's efficiency. Recommend a qualified contractor to correct.

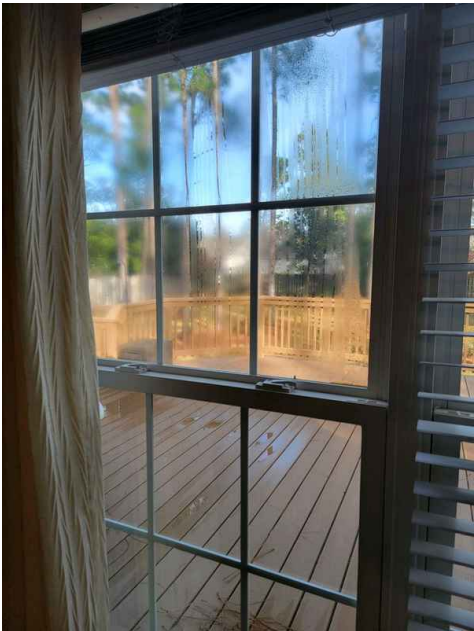
FAILED SEAL

Observed condensation between the window panes, which indicates a failed seal. This reduces the efficiency of the insulating effect of the window and may allow water intrusion. Recommend qualified window contractor evaluate & replace.

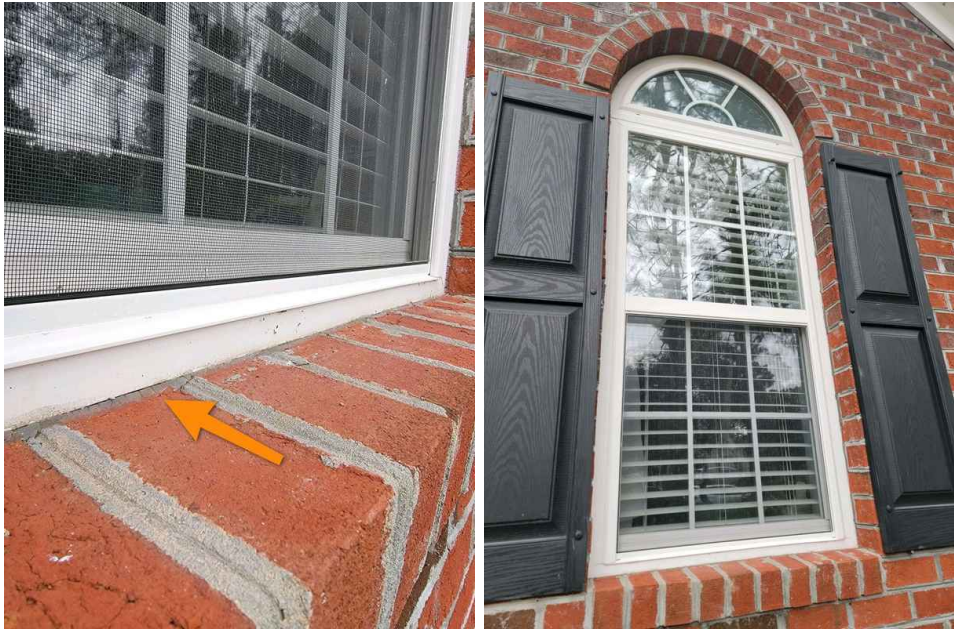
10.2.2 Windows

FAILING SEAL

The sealant around the windows is failing. This will allow water intrusion and damage to the underlying structure. Recommend qualified contractor to assess all window sealants and repair as necessary.

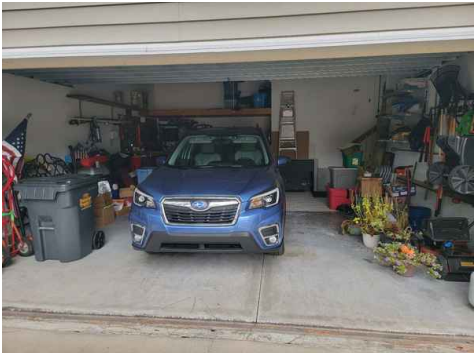
### OBSTRUCTED VIEW - OCCUPANT BELONGINGS

The inspection of the garage was slightly limited due to occupant's belongings. There may be hidden or latent issues not otherwise found during this inspection.

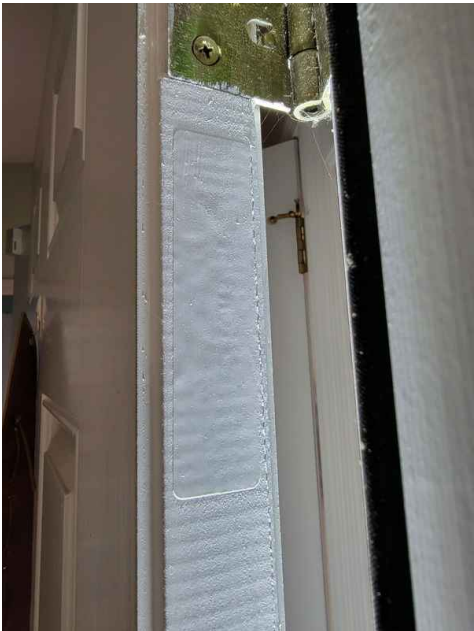
### CANNOT BE VERIFIED AS FIRE RATED

The occupant door from the garage to the living space cannot be verified as fire-rated. The label has been painted over. Recommend a qualified contractor to assess and replace as necessary.
